## IMPORTANT SAFETY NOTICE

**SUBJECT: All RIDGID® Micro CG-100 Combustible Gas Sniffers (Catalog #26148)  
Produced before February, 2008:**

March 3, 2008

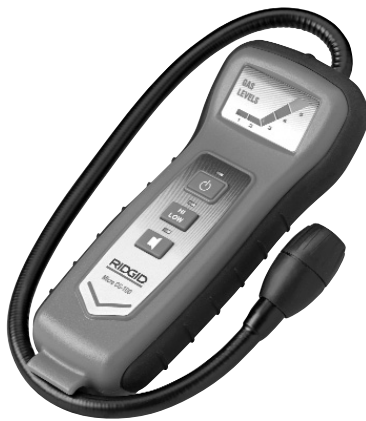
Micro CG-100 Combustible Gas Sniffer

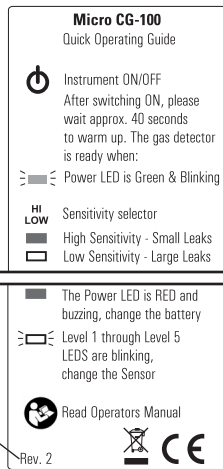
Correct Operating Decal On Back of Gas Sniffer

**All RIDGID Micro CG-100 Combustible Gas Sniffers (Catalog #26148) produced before February, 2008 are affected by this issue.** Affected Gas Sniffers can be identified by looking at the operating decal on the back of the unit and the user manual. If the decal and user manual are not marked with "Rev. 2" or "Revision 2" higher (*see above photos*), they are not correct and need to be retrofitted. Any Gas Sniffer produced after February 2008 has the correct decal and manual and is not subject to this safety notice.

Please take immediate steps to determine if you have any of these products in your possession. Do not use affected Gas Sniffers until they have been retrofitted. Contact Ridge Tool Technical Services at (800) 519-3456 or [TechServices@ridgid.com](mailto:TechServices@ridgid.com). Ridge Tool will provide parts and information to retrofit the Gas Sniffer with the correct decal and manual.

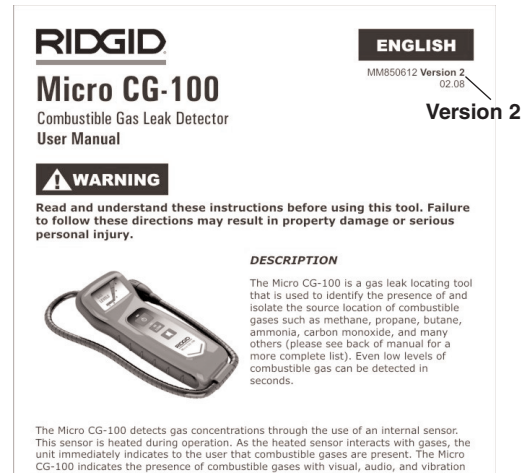
Correct User Manual

**This is a Product Retrofit Notice.** Ridge Tool recently determined that the on-product operating decal and user manual included with these Gas Sniffers are incorrect. As a result, a user would think they are detecting combustible gases down to concentrations of 40 parts per million (ppm), when in fact they are only detecting combustible gas concentrations down to 400 ppm. **This could lead to combustible gas concentrations of less than 400 ppm not being detected.**
